Cemetery Design Guidelines

Following are guidelines for the preservation and restoration of the Memory Hill Cemetery in Milledgeville's historic district. This section provides guidance to volunteers, caretakers, and nonprofit organizations that have an interest in preserving the National Register listed cemetery. These guidelines offer technical information regarding historic materials and appropriate restoration methods.

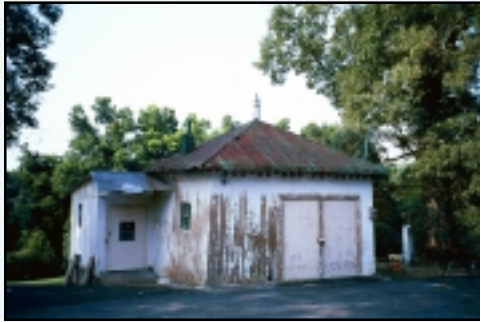
The Memory Hills Cemetery has two historic accessory buildings in fair to poor condition which are significant features of the cemetery. The care and rehabilitation of these buildings should follow the residential rehabilitation guidelines in this manual.

This accessory building at Memory Hills Cemetery is in poor condition and is in need of repair.
